NWHC REPORT 7967
DECEMBER 1979

A
**NAVAL WEAPONS HANDLING
CENTER**

**REPORT OF DROP TEST
CONTAINER OFFSHORE
TRANSFER SYSTEM
(COTS)**

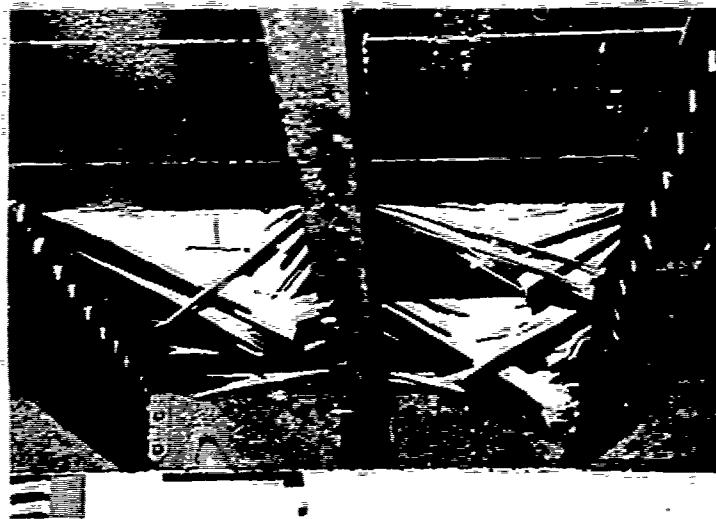
The fiberglass reinforced container was tested twice in full load configuration on the bare surface in a flat and oblique attitude. Damage was restricted to the wood flooring. There was no damage to the frame (Figure 15).

Figure 15 - Flooring Damage
